Investigation of Solar Collector Fire Incident

**INVESTIGATION OF SOLAR COLLECTOR
FIRE INCIDENT**

William D. Walton

August 1981

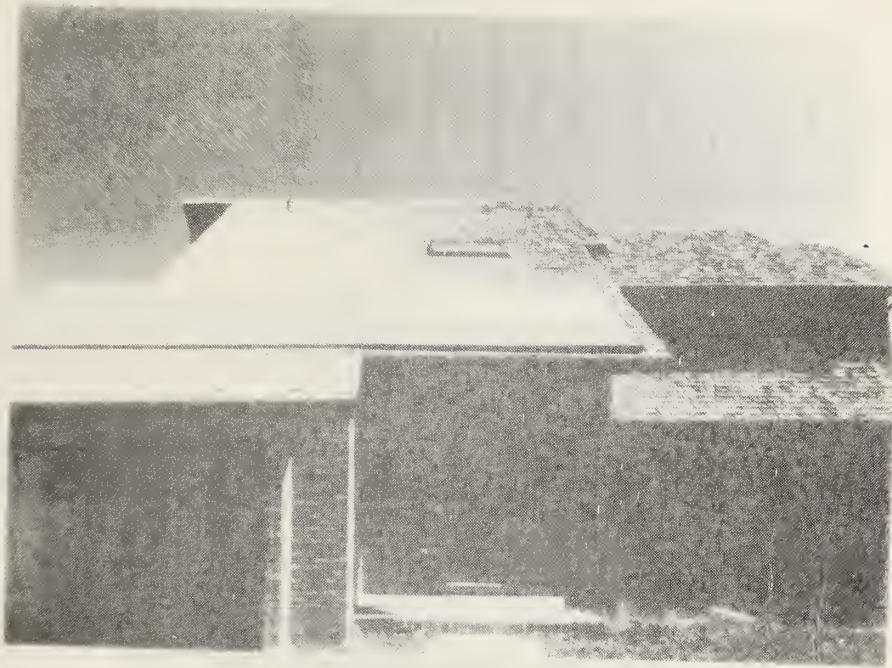
Figure 4. House on lot 24

Because each house is of a different design, the roof construction and collector mounting varies with each house. All of the collectors on the houses on lots 6 and 33 are mounted on roof decks insulated with 6 inches (15 cm) of kraft paper-faced glass fiber insulation between 2 x 8 inch joists which are 24 inches (61 cm) on center. A layer of gypsum board underneath forms the interior finish of a cathedral type ceiling. A cross section of this assembly is shown in figure 8. Collectors 1 and 6 on lot 22 appear to be mounted over uninsulated roof decks and the remaining collectors on this house over the same type of insulated deck shown in figure 8. All collectors on the house on lot 24 appear to be mounted on an uninsulated roof deck.

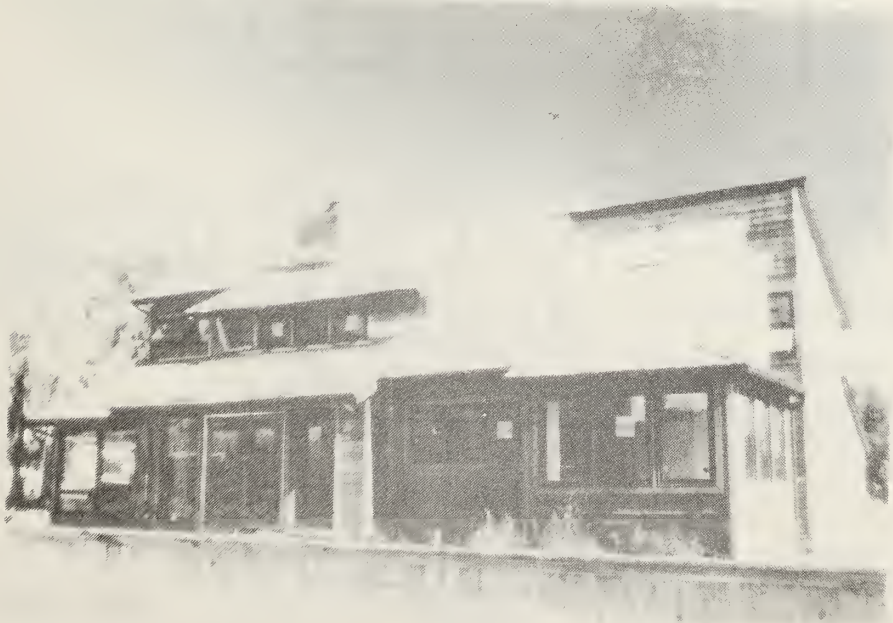
Figure 5. House on lot 33

Four houses utilizing identical solar collectors from the same manufacturer are located in a housing development in Boulder, Colorado. The houses are of new (1979-1980) construction, each of a different design, all located within approximately one block of each other. Figure 1 shows the layout of the site. The houses on which the collectors were mounted are located on lots 6, 22, 24, and 33. Figures 2 - 5 show the location of the collectors on the houses on lots 6, 22, 24, and 33, respectively, as of early July 1980. (Note: the glazing on the collectors was painted white after the fire to reduce solar heat gain.) Since that time, all of the original collectors have been replaced with collectors of a different design. All collectors face due south and it can be seen from the figures that the houses on lots 6 and 24 each have 9 collectors and the houses on lots 22 and 33 have 10 collectors each. The house on lot 33 was the site of the fire and the 10 collectors on the house were mounted in two rows of 5. The collectors had been removed and the fire damage to the roof repaired prior to the photograph.

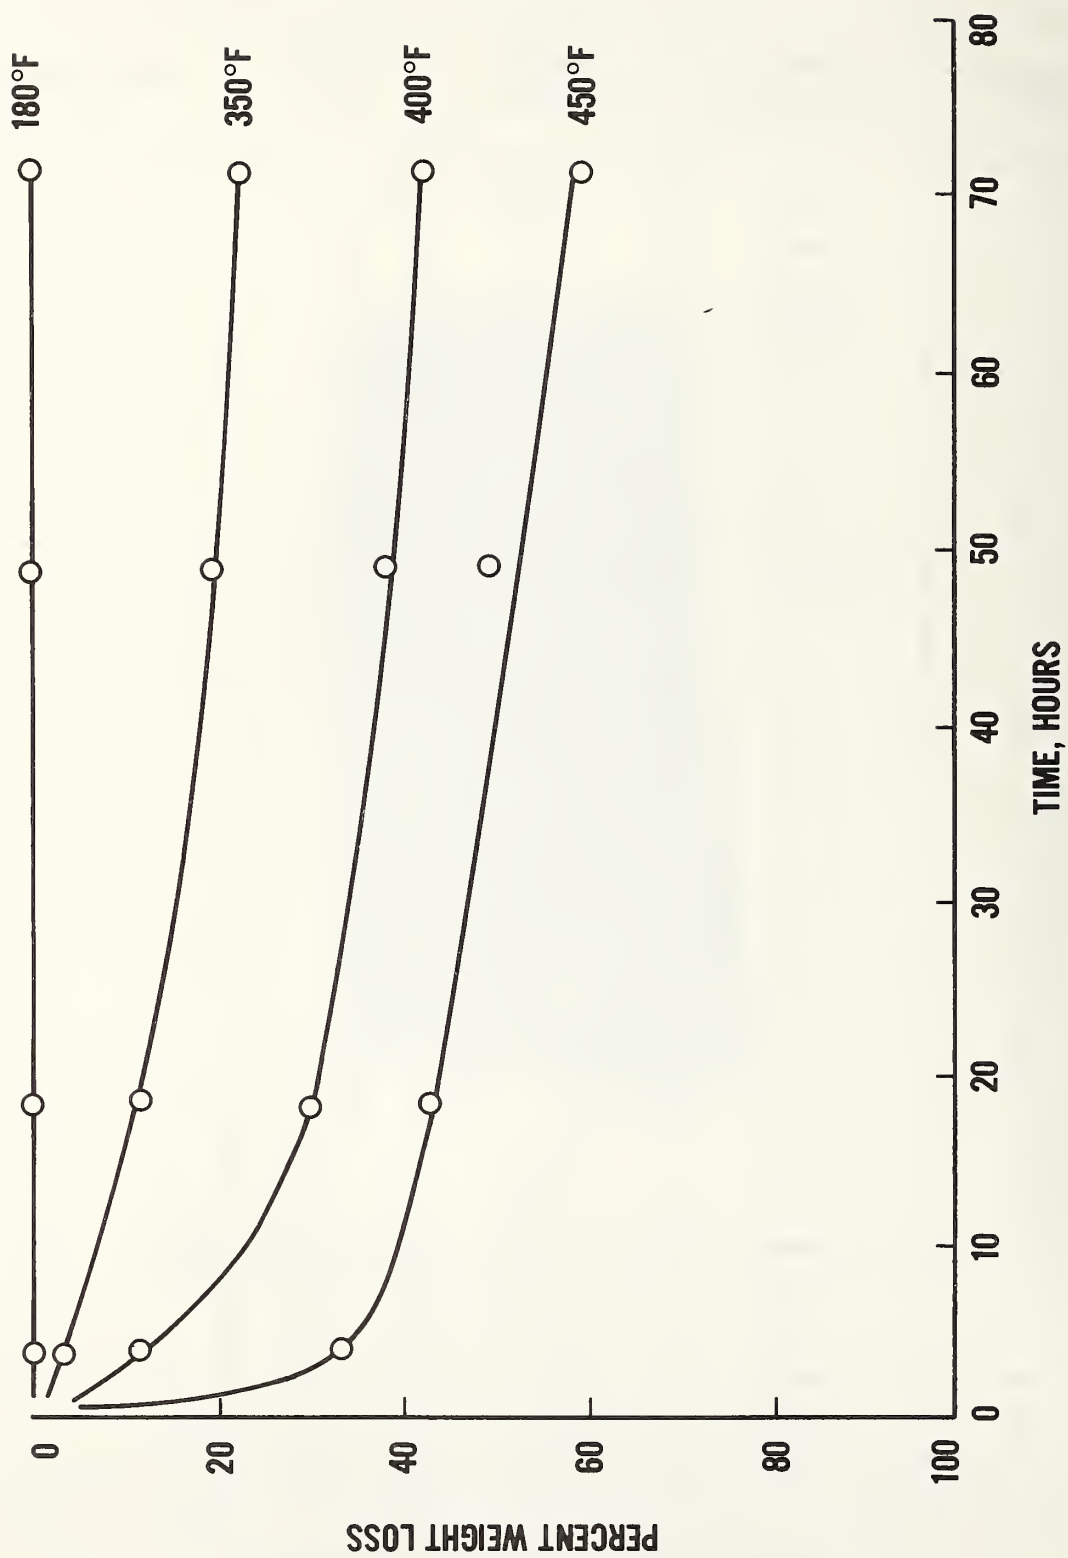
Figure 22. Isothermal weight loss of polyurethane foam

would generally be considered safe. The maximum permissible temperature for polyurethane from insulation is given in the standard as 327°F (164°C). Unpublished test results from the Boeing Company shown in figure 22 indicate that the polyurethane tested experienced approximately a 20% weight loss when exposed to 350°F (177°C) for 72 hours. The urethane tested had noticeably darkened after the exposure. These results indicate that 327°F (164°C) is not a safe maximum permissible temperature for urethane. This example is an indication of the inadequacy of the current knowledge on exposure of materials like urethane to elevated temperatures. This is further complicated by the fact that urethane foam describes a family of materials with varying properties. Therefore, it is recommended that research be conducted with an emphasis on developing a test method by which the effect of long term exposure of materials at elevated temperatures can be determined.
